# Remedial Investigation Summary

WILCOX OIL COMPANY, BRISTOW, OK MARCH 15, 2018 [DRAFT 3-9-18]

WILCOX OIL COMPANY REMEDIAL INVESTIGATION SUMMARY

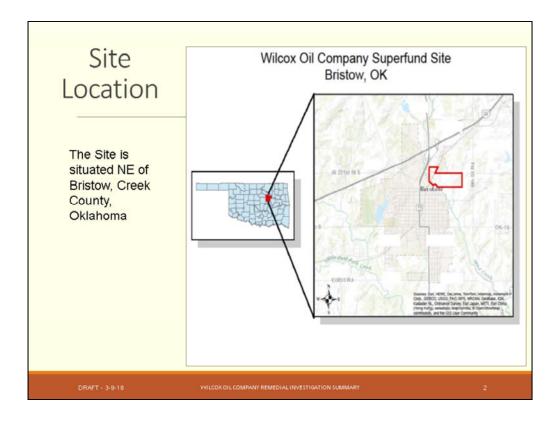
The site is located just northeast of central Oklahoma and just northeast of Bristow.

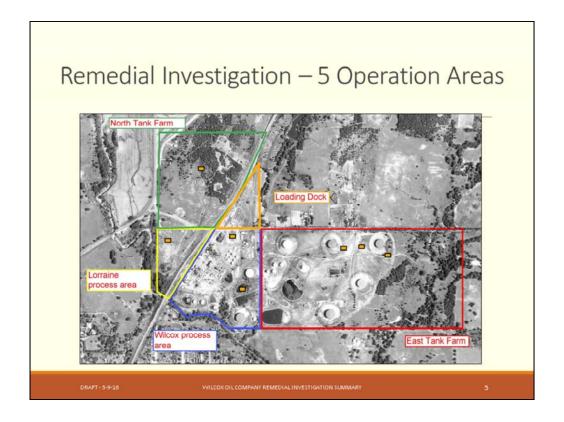
The site has been broken down into 5 areas based on operating history. This is a 1956 aerial photograph that shows each of the site's operation areas.

Orange squares represent residences. 3 of which are currently occupied.

North Tank Farm: old Lorraine Refinery (~27 acres)

Lorraine Process Area (~9 acres) 42000 gal capacity tanks (~15-20 tanks)

Wilcox Process Area (~27 acres)

Loading Dock (~7 acres)

East Tank Farm: old Wilcox Refinery (~80 acres) 55,000barrel capacity tanks (10-15 tanks)

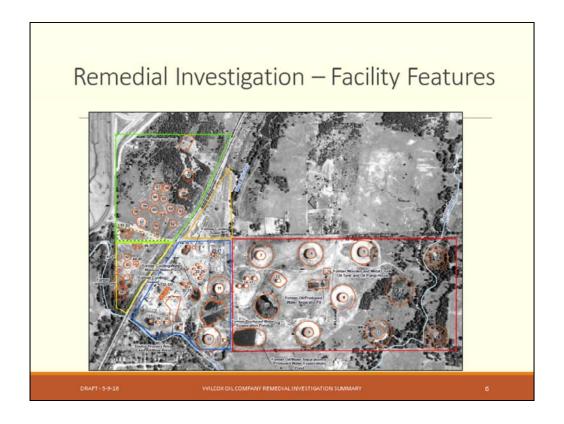
This figure shows some of the features associated with the refinery operations and the challenges we face.

The Sanborn Insurance Maps indicate that the property contained about **80 storage tanks of various sizes**, a cooling pond, separation ponds, and around **10 or more buildings housing refinery operations**. The map also indicated that **crude oil**, **fuel oil**, **gas oil**, **distillate**, **kerosene**, and benzene (petroleum ether) were all stored on the property by the Lorraine /Wilcox Refining Company.

Some wastes that may be associated with this type of facility include **crude oil**, **tank residues**, **brine**, **acid and caustic residue**, **heavy metals**, **petroleum**

**products, coke, sulfur compounds, and solvents**. Waste management practices are unknown for this facility.

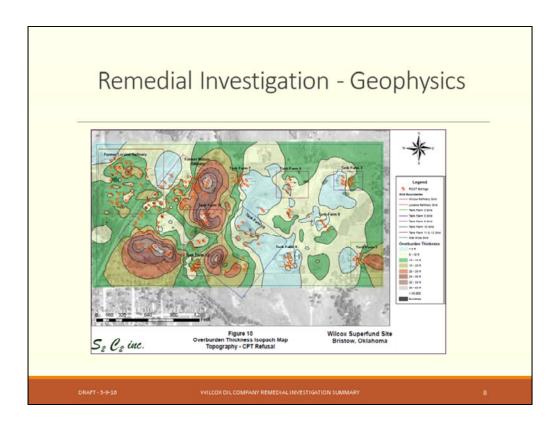
Thickness overburden varies over the site from <5ft to greater than 35/40 ft.

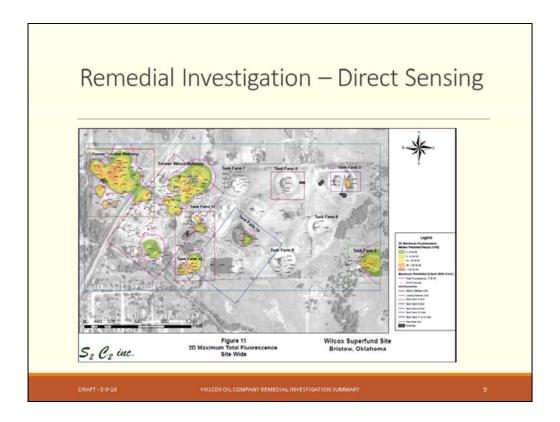
With the **geology mapped** and the documentation of **refinery processes from Sanborn maps and aerial photographs**, we moved forward using a combination of **investigative tools**: **Rapid Optical Screening Tool**, **X-Ray fluorescence**, and **direct push technologies** to further delineate potential source areas.

The Rapid Optical Screening Tool used onsite was - Light induced fluorescence technology. Petroleum contains varying amounts of polyaromatic hydrocarbons or PAHs. Electrons in these molecules will absorb light energy and release that energy in the form of fluorescence. Using LIF, an ultraviolet light is emitted into the surrounding soils. The contaminants in the oil waste fluoresce when hit with the UV light and the location is recorded by the sensor. Based on the fluorescence signatures, we are able to map potential source areas based on relative fluorescence and potential type of product present.

Light induced fluorescence is a screening tool.

- It does not map the lightest hydrocarbon fractions or the heaviest.
- Information is associated with the mid-range hydrocarbon fractions. Note: the refinery operations produce the lighter products such as gasoline, while the storage tanks held crude oil direct from the fields. These crude oils represent the heavier fraction.
- This technology does not <u>quantitatively</u> define the contaminant detected but

rather focusses efforts in areas where contamination is most likely to be present.

It does not provide information on metals.

Because the light induced fluorescence technology only provided screening data, direct push technology was used to target areas for sampling in an attempt to identify and get some indication of the type and concentration of the contaminant present.

**Direct push technology** was used to collect samples from the areas **providing the highest fluorescence signatures**. Results indicate the presence of **petroleum hydrocarbons in the gasoline, diesel, and oil ranges and PAHs.**

The **XRF** was used to **screen for metals**, with a focus on lead. Results indicate that the lead is highest in the process area where the fuel product was refined to remove excess sulfurs and other impurities.

During Phase 1, we were able to complete 200 LIF locations

68 East Tank Farm

34 Lorraine

98 Wilcox

30 direct push locations

>100 XRF locations throughout

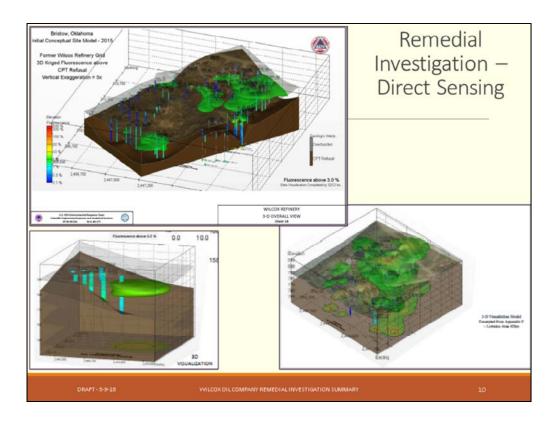
Not only did the **light induced fluorescence** provide us with a horizontal indication of potential waste material, but it also provided a **vertical indication or depth profile of the potential waste material.** Using that information, these **3D images** of the subsurface and the depth location of the potential waste material **were developed**.

As you can see from these maps, the potential waste material **ranges between 5** and **20** feet below ground surface.

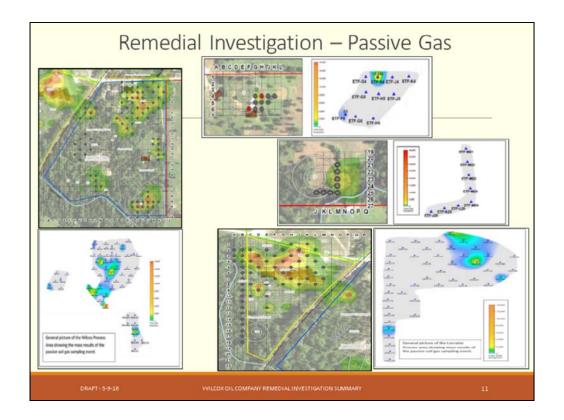
One of the media we are concerned about is **air**, specifically **vapors that can be produced from the waste source material**. We used **passive gas samplers** to **map** locations where **vapors** from the waste source material may be present. We also **sampled indoor air** within three buildings that are located within the former process area boundaries for Wilcox and Lorraine to **determine if these vapors are moving into the buildings where people can breath them**.

**During Mobilization 1:**

149 total locations

Based on the data, the source areas have the potential to create vapors. In addition, some indoor air data show that contaminants exceed the screening numbers. The primary indicator contaminants include dichlorobenzene, benzene, ethylbenzene, toluene, and Xylene.

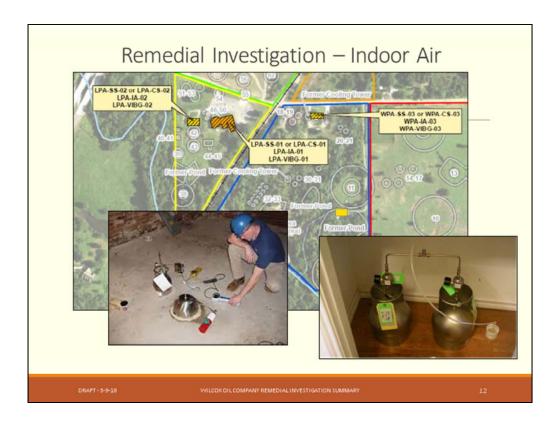
Benzene, dichlorobenzene, ethylbenzene are the primary contaminants detected. Contaminants were detect above the screening levels indicating that the pathway requires further evaluation. These residential properties are currently vacant.

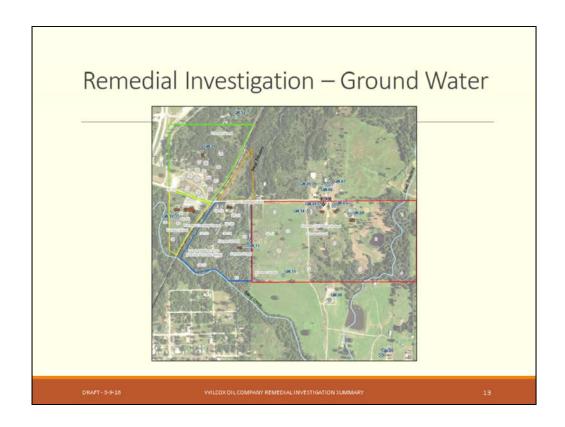
Approximately 14 wells sampled.

Only one well was found to be unacceptable for drinking. This is the well located on the Lorraine process area and it has been abandoned.

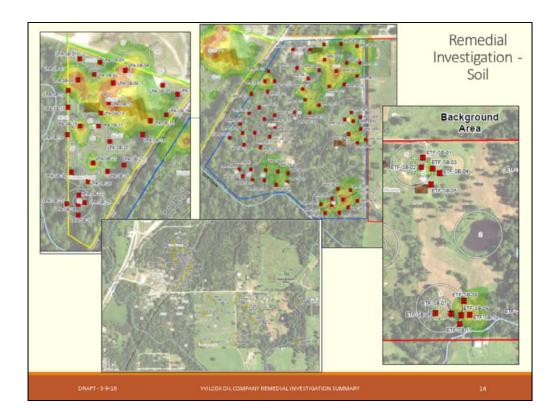
The dots represent the soil boring locations. These locations were selected based on the results from the light induced fluorescence survey. These soil borings will provide us with data that will further our understanding of what waste source material is present, will refine the horizontal and vertical extent, and will identify the contaminants that are present as well as their concentrations.

In addition, the soil borings are located along areas that may be in contact with Sand Creek. These boring will provide data that will assist us in understanding whether contamination is moving from the site and into the creek.

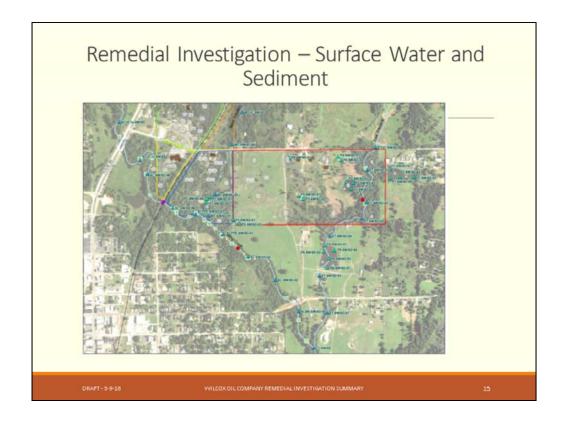
In April 2017, 10 surface water samples from 10 locations along sand creek were collected. Data are below screening levels for humans. Further review related to ecolgocial risks is needed.

As part of the continued site investigation activities: all other water bodies and ponds were sampled—surface water and sediment. Sediment samples were collected from Sand Creek as well as additional surface water.

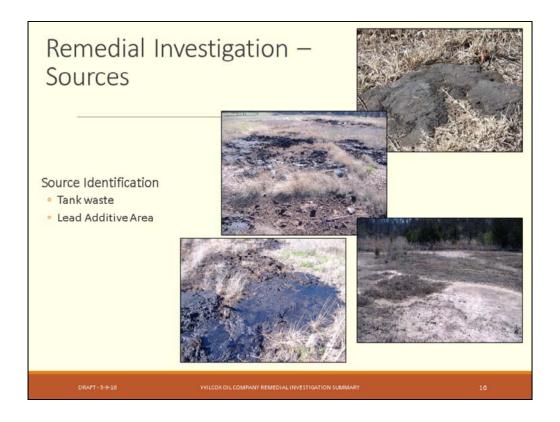
Source material is defined as material that includes or contains hazardous substances, pollutants or contaminants that act as a reservoir for migration of contamination to ground water, to surface water, to air, or acts as a source for direct exposure (EPA, 1991). Site investigation activities identified two source materials, tank sludge/solids and the lead additive area solids

tank sludge/solid waste that can be either a contaminated oily tar-like viscous liquid and/or a black dry solid

Lead additive area: silty sparkling sand and a white, salt-like substance

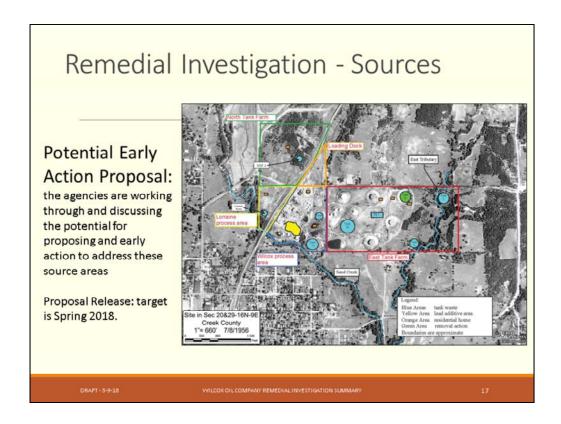
9 Sources

5 migration Pathways to the Creek

4 Residential Property exposure Pathways: direct and ingestion

Risk Reduction: Human and Ecological receptors

Removal action Sept/Oct 2018: 1349 tons of tank source material removed
